National Dam Inspection Program.
PA-482 Dam (NDI I.D. Number PA-469,
DER I.D. Number 63-72), Ohio River
Basin, Tributary of Harmon Creek,
Washington County, Pennsylvania.
Phase I inspection Report.

May 79

PA-482 DAM
NDI I.D. NO. PA-469
DECEMBER 1, 1978

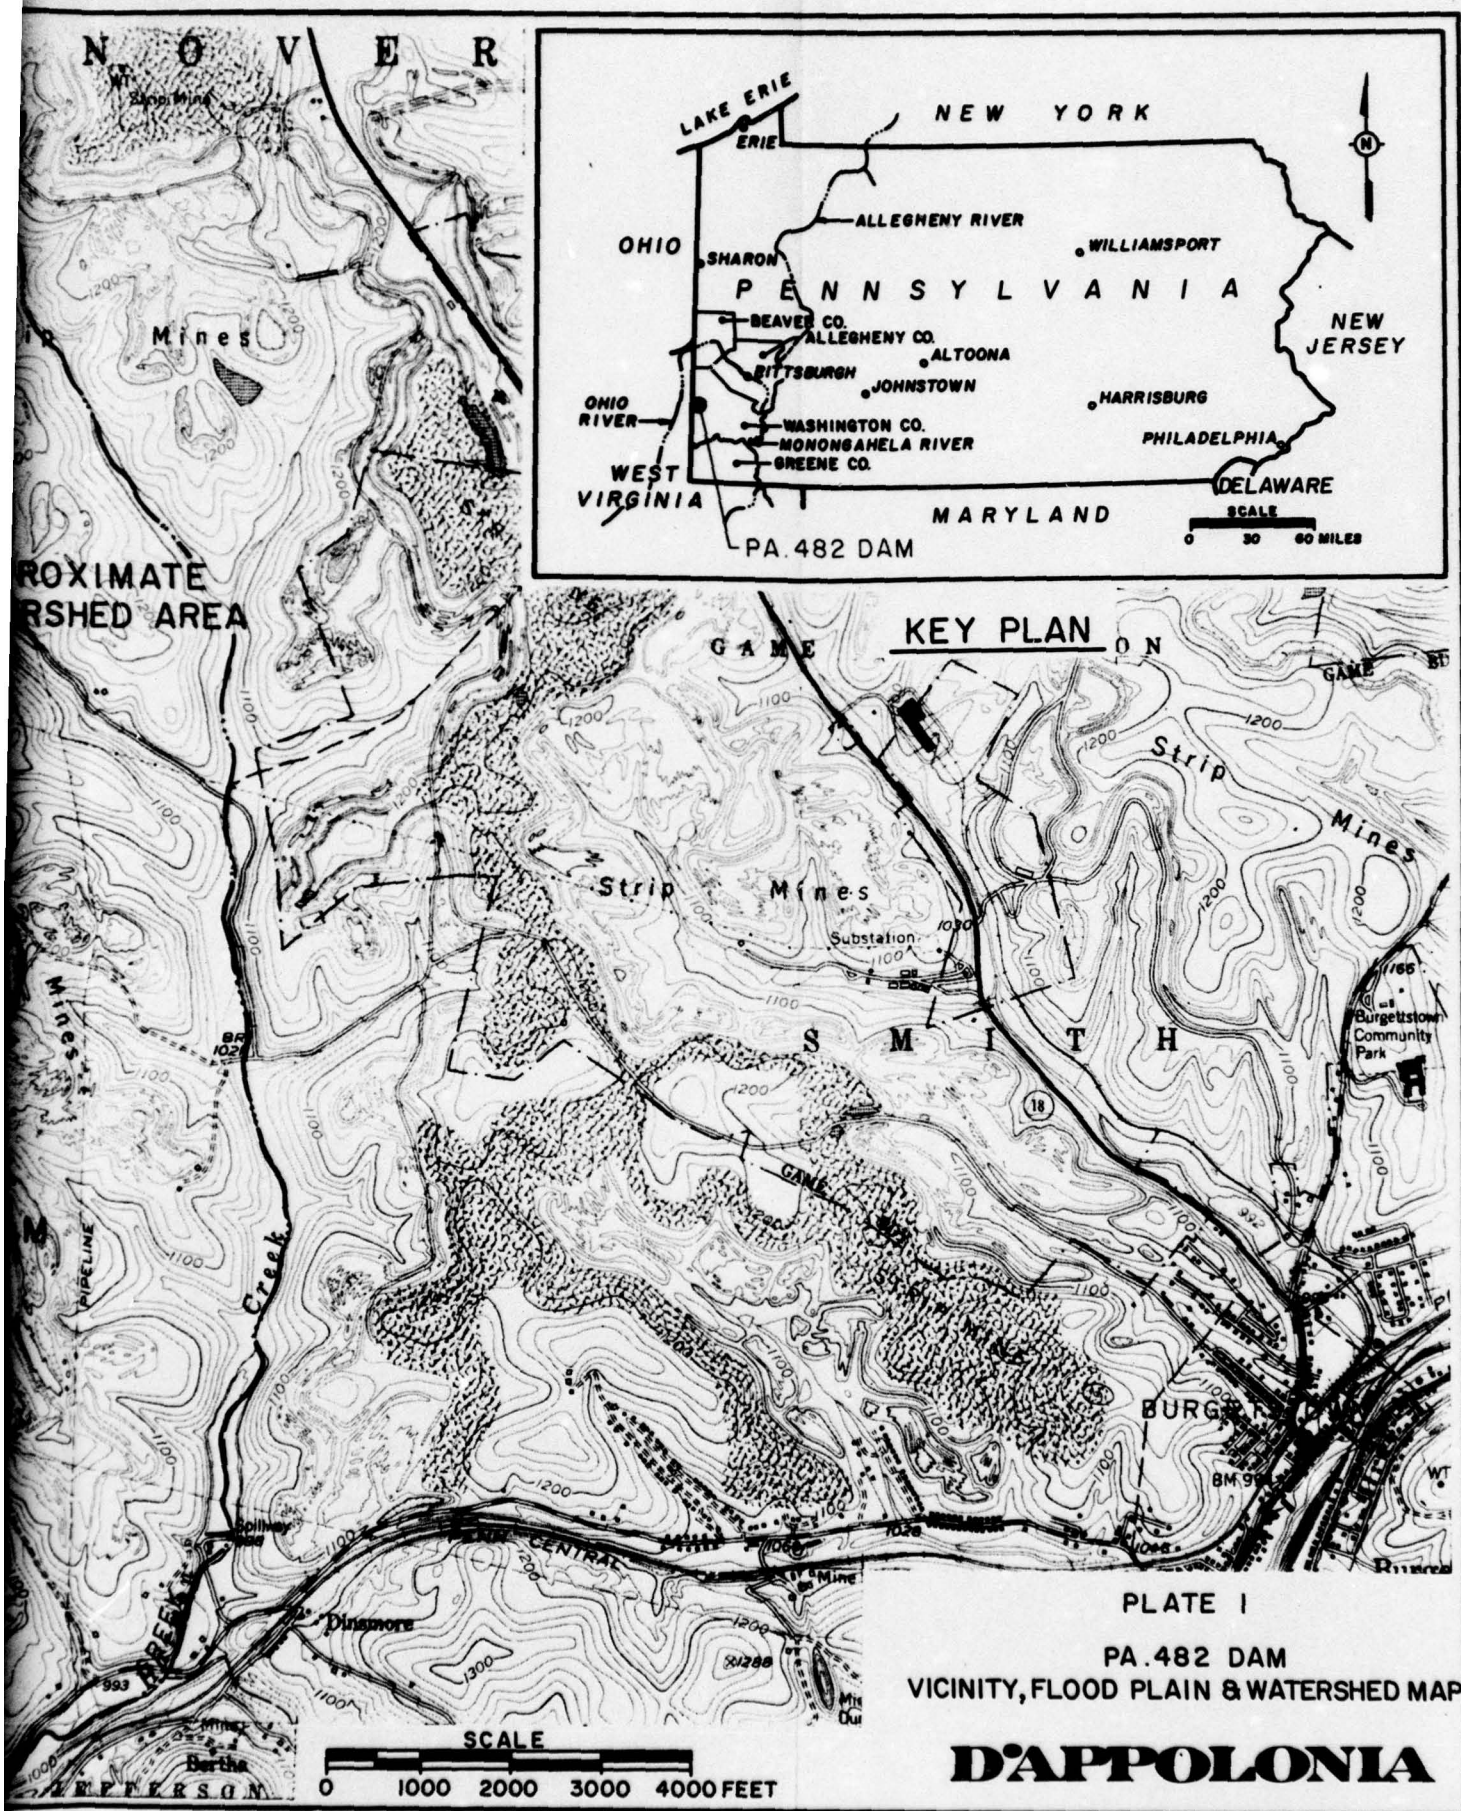
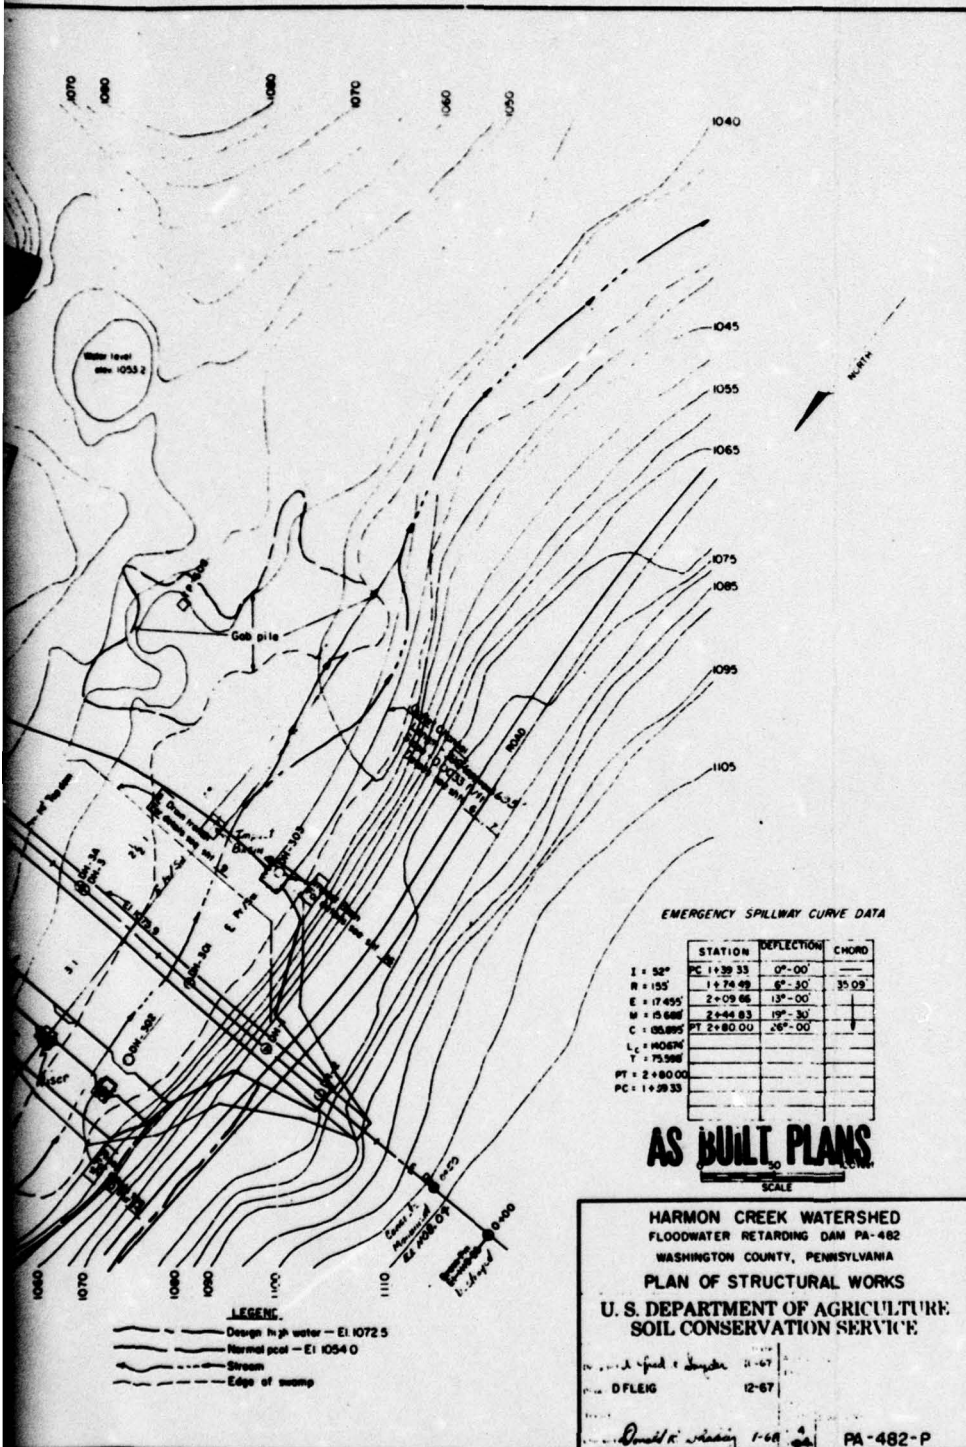
PLATE 2

a. As designed, the dam (Plate 2) is a zoned embankment including an internal drainage system beneath the downstream slope (Plate 3). Three zones were identified. Zone I, which is classified as silty clay with a plasticity index of 20, consists of a 2-foot-thick blanket starting from the upstream toe of the dam and terminating at the trench drain beneath the downstream slope. Zone I also extends into the cutoff trench along the center line of the dam. Zone II constitutes the core section of the embankment. The Zone II material was described as highly weathered siltstone and classified as silty clay. Zone II, extending from the top of Zone I to a level about 5 feet below the dam crest, is about 60 feet wide at the base and 16 feet wide at the top. Zone II, which constitutes the outer shell sections of the embankment, consists of compacted, weathered siltstone.

The emergency spillway is a trapezoidal earth channel excavated into the left abutment (Plate 2). The bottom width of the trapezoidal channel is 200 feet with side slopes of 3 to 1 on the embankment side and 2 to 1 on the abutment side. A 30-foot-wide level section located at Elevation 1070.6 in line with the axis of the embankment constitutes the control section of the spillway.
